# **Selected Images of the Effects of the October 15, 2006, Kīholo Bay-Māhukona, Hawai‘i, Earthquakes and Recovery Efforts**

Data Series 506

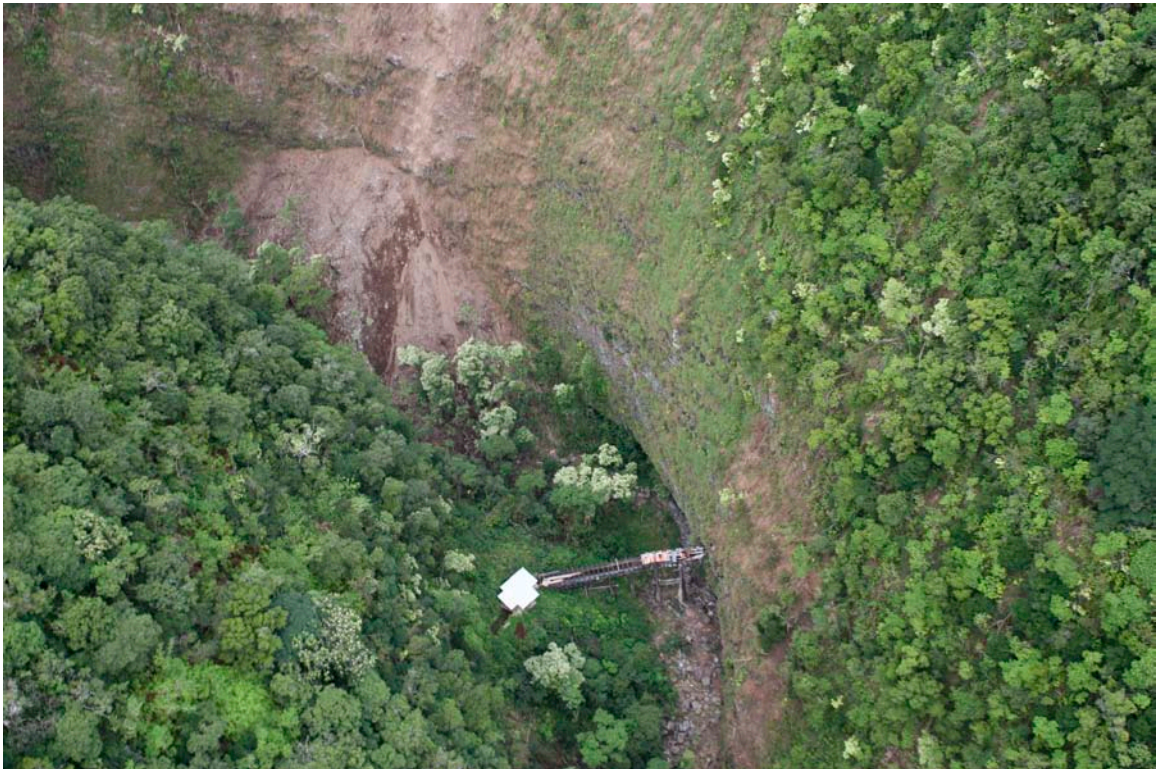
19.12. Close-up aerial view of the debris pile at the base of the abraded wall (see photo 19.10 (jpk6025) and 19.11 (elh1253)) near an irrigation flume in Pololū Valley (view to the west). USGS photo by E.L. Harp, 11/8/2006 (elh1254).

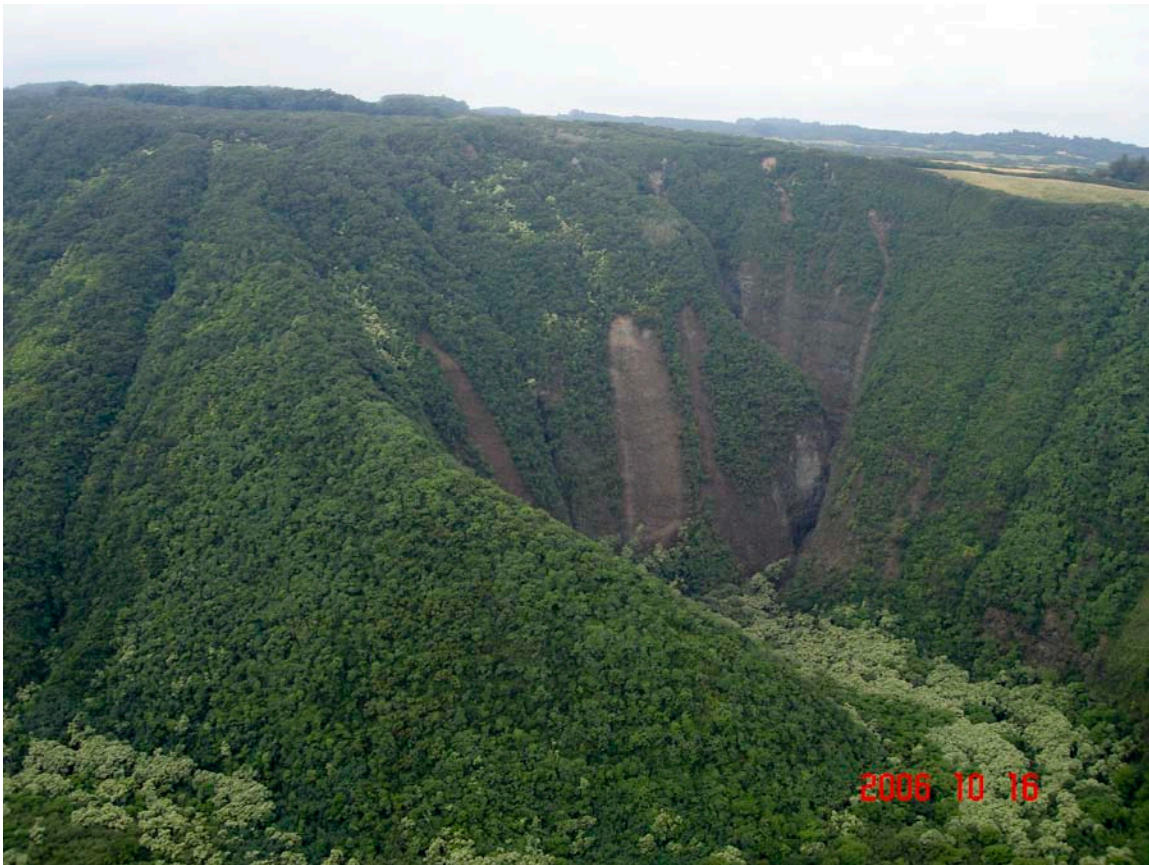
19.13. Aerial view of cliffs sheared of vegetation by rock falls in amphitheater-headed Waiakala'e Gulch on the west wall of Pololū Valley (view to the west-southwest). DLNR photo by S. Bergfeld, 10/16/2006 (sb927).

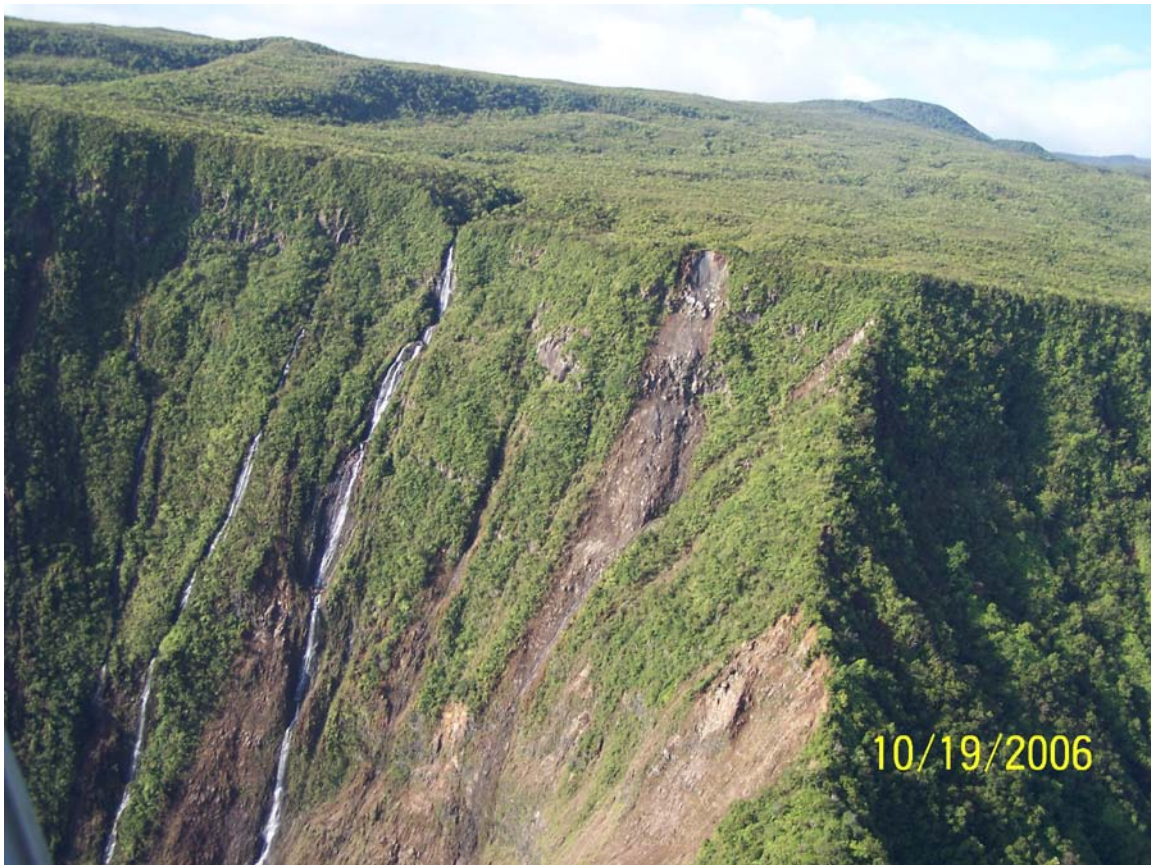
19.14. Aerial view of waterfalls, rock and soil slides, and knife-like ridge in Pololū Valley (view to the west). DLNR photo by K. Gooding, 10/19/2006 (kg1459).

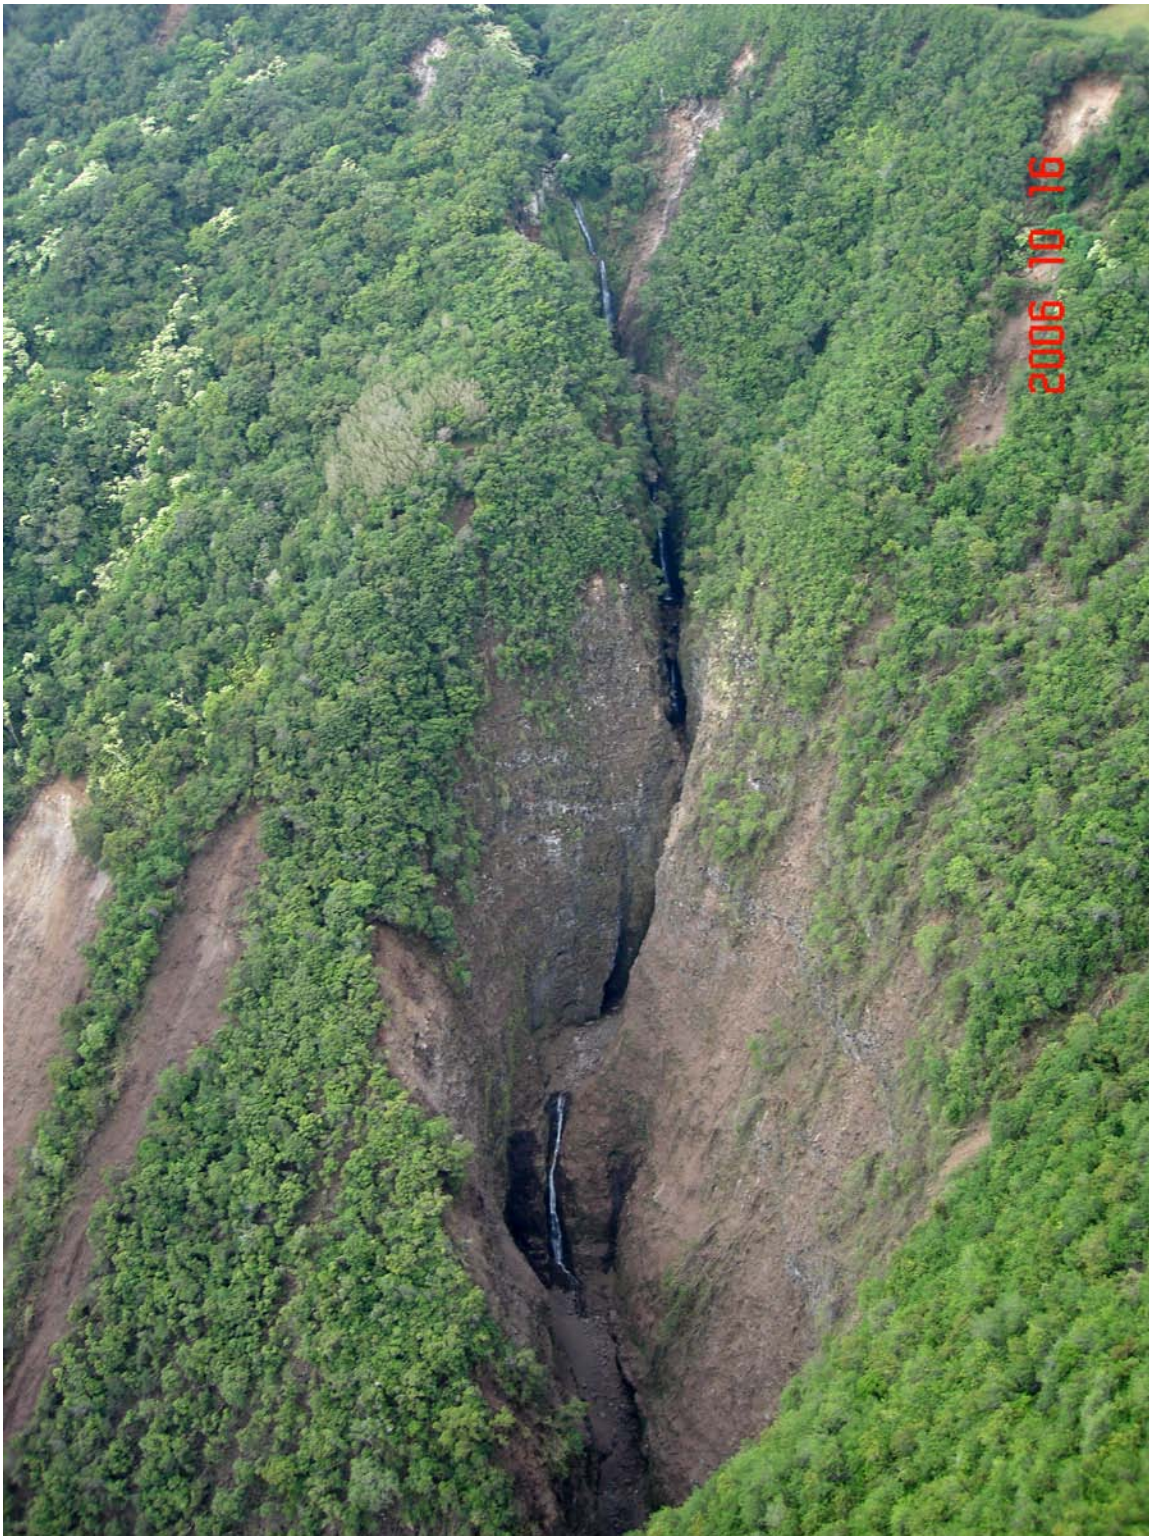
19.15. Aerial view of terraced Waiakala'e Falls, blocked in places by rock-fall debris (view to the south-southwest). DLNR photo by S. Bergfeld, 10/16/2006 (sb929).

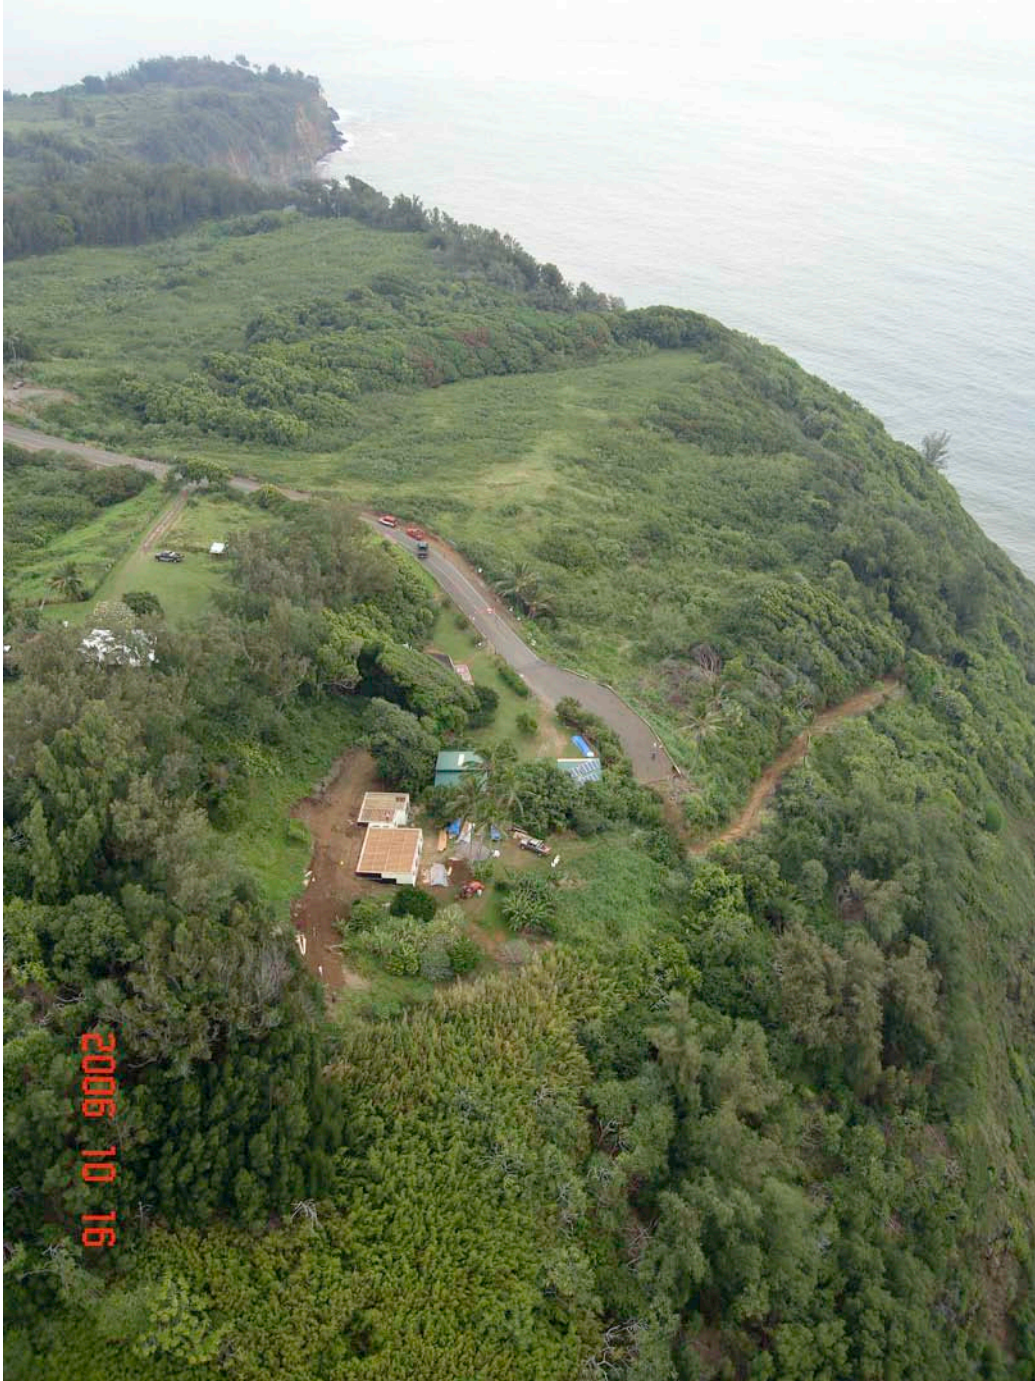
19.16. Aerial view of Niuli‘i-Hāwī Road, the Lookout, and the head of the trail into Pololū Valley (view to the north). Both the Lookout and the trail were closed after the earthquake. DLNR photo by S. Bergfeld, 10/16/2006 (sb930).

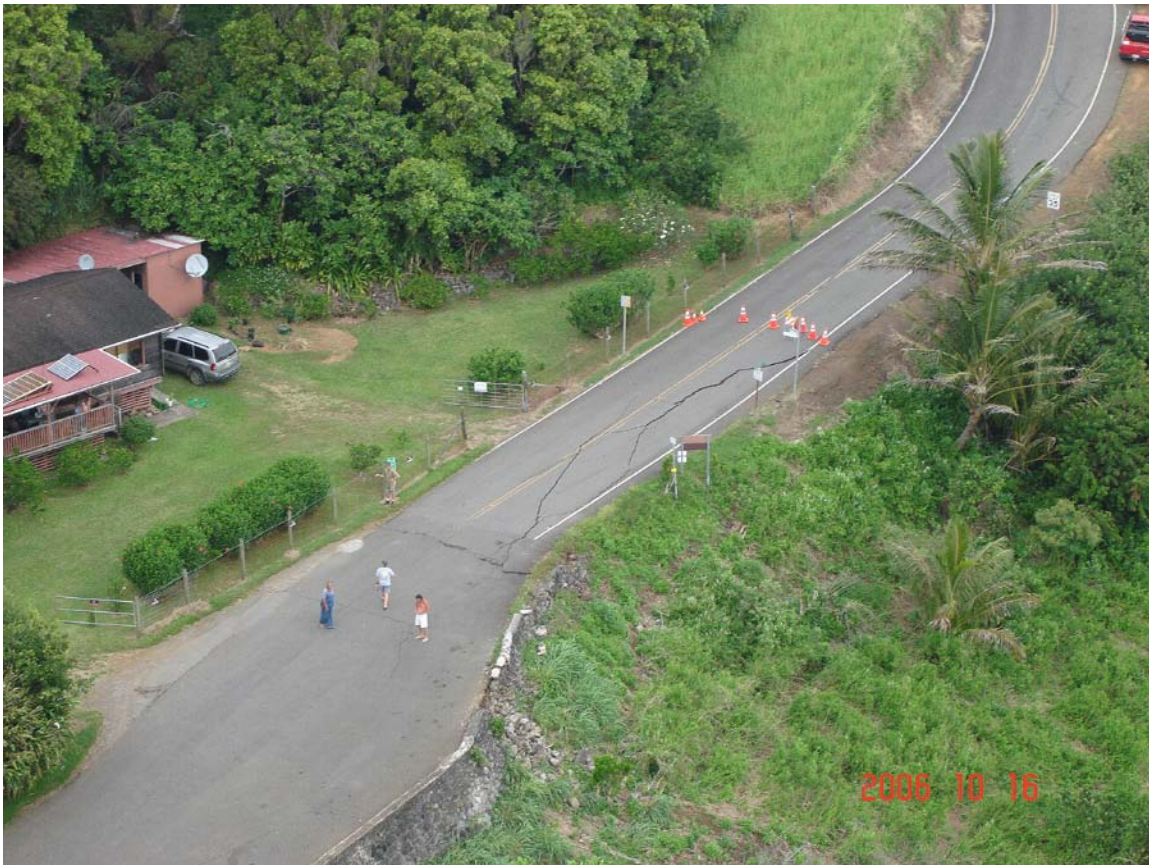
19.17. Aerial view of road cracks and collapsed rock retaining wall at Pololū Valley Lookout (view to the north). DLNR photo by S. Bergfeld, 10/16/2006 (sb931).

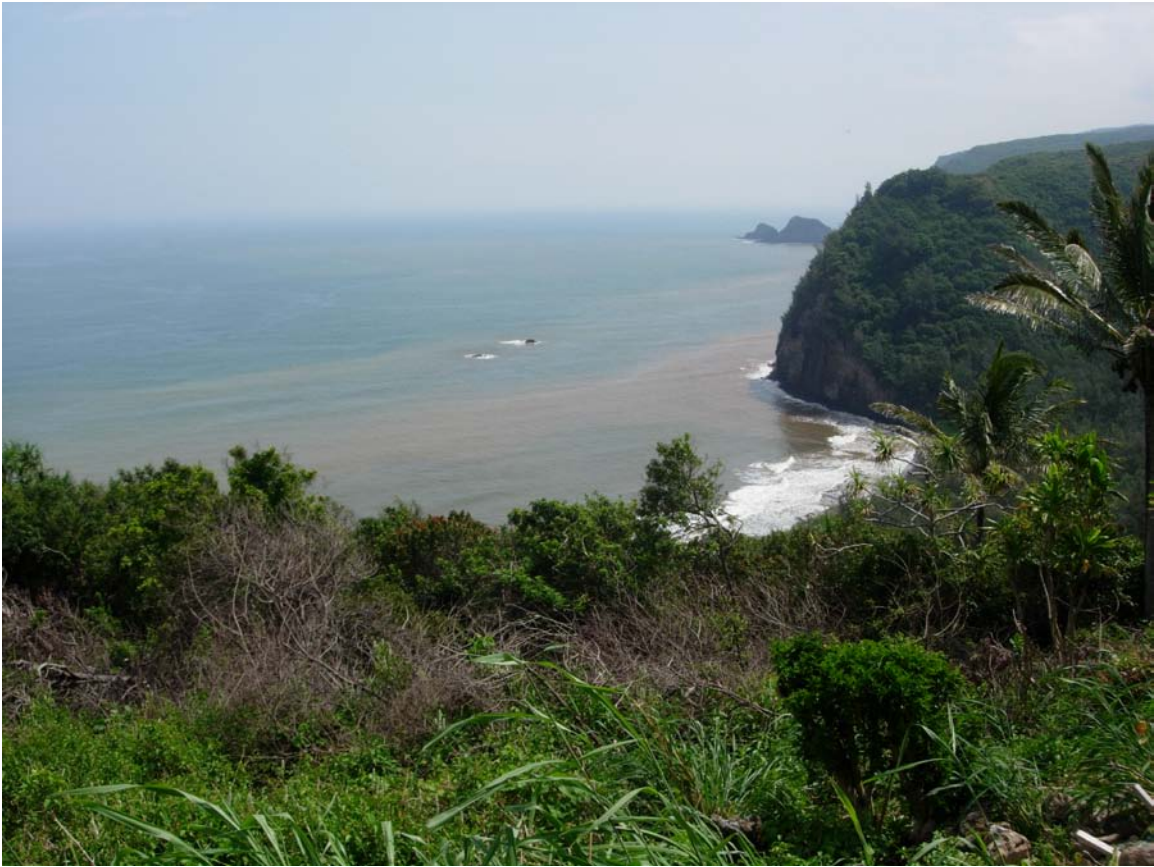
19.19. View, from the overlook, of the mouth of Pololū Valley, with Paokalani and Mokupuku islets in the distance. The coastal waters are muddy from the rock-fall and rock-slide debris off the sea cliffs, washed down by heavy rainstorms for several days after the quake (view to the southeast). USGS photo by M.P. Poland, 10/19/2006 (mpp006).

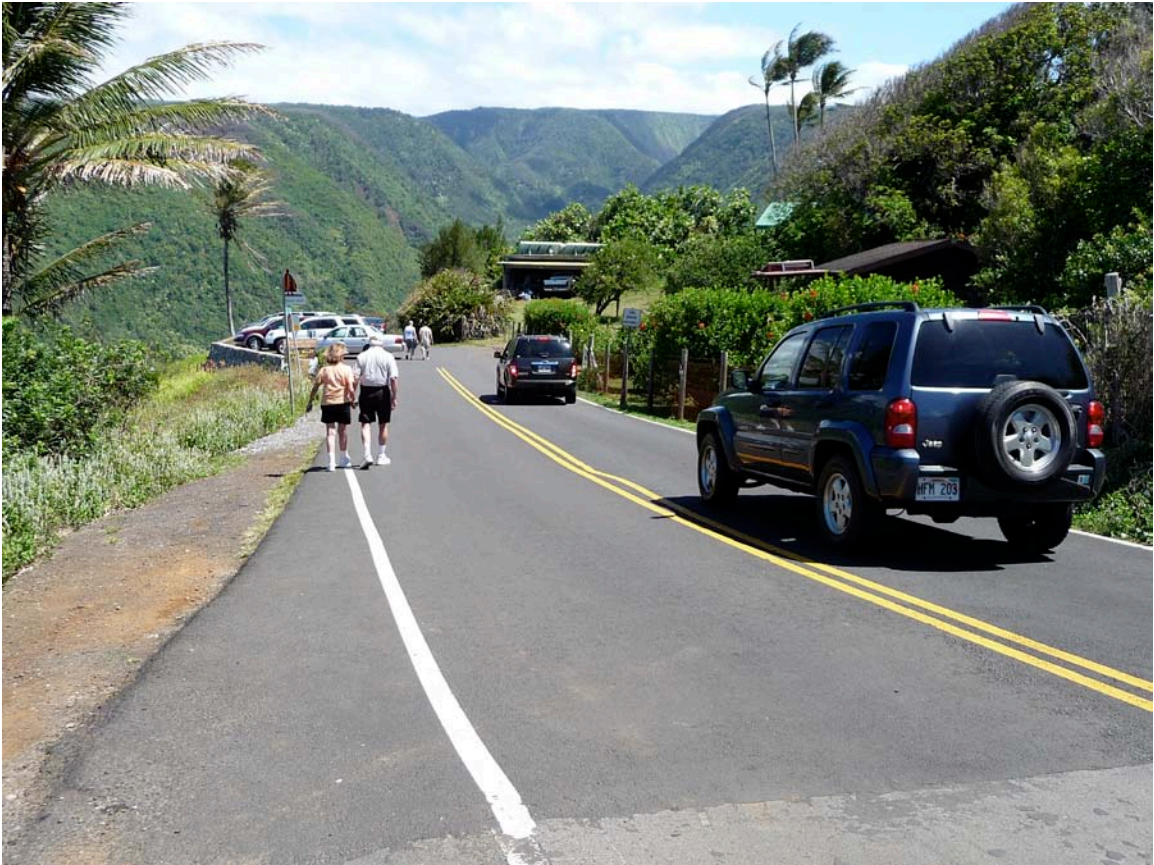
19.23. Pololū Valley Lookout, a popular tourist destination, draws visitors after the road is repaved and the retaining wall rebuilt (view to the south). USGS photo by N.A. Ikeda, 6/25/2008 (nai304).

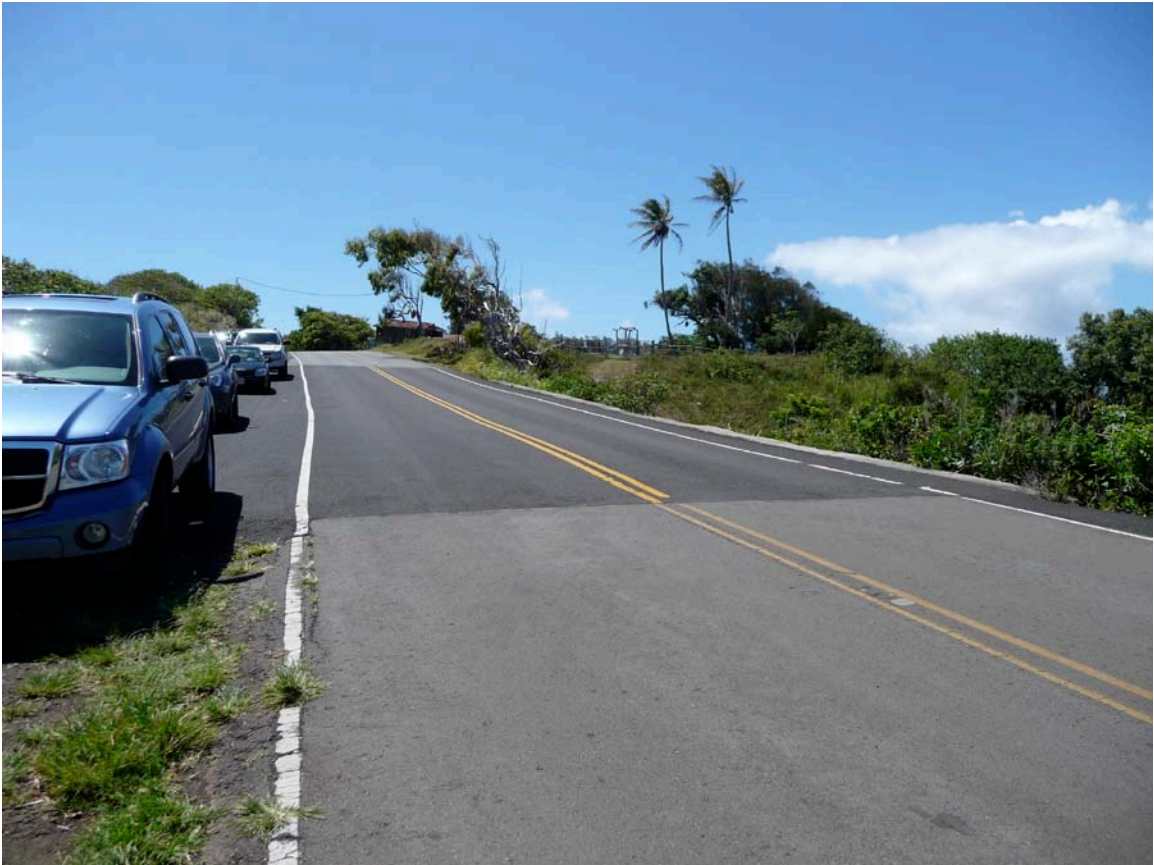
19.24. View of newly repaved Niuli‘i-Hāwī Road, which enables visitors to enjoy the view from the Pololū Valley Lookout once more (view to the northwest). USGS photo by N.A. Ikeda, 6/25/2008 (nai308).

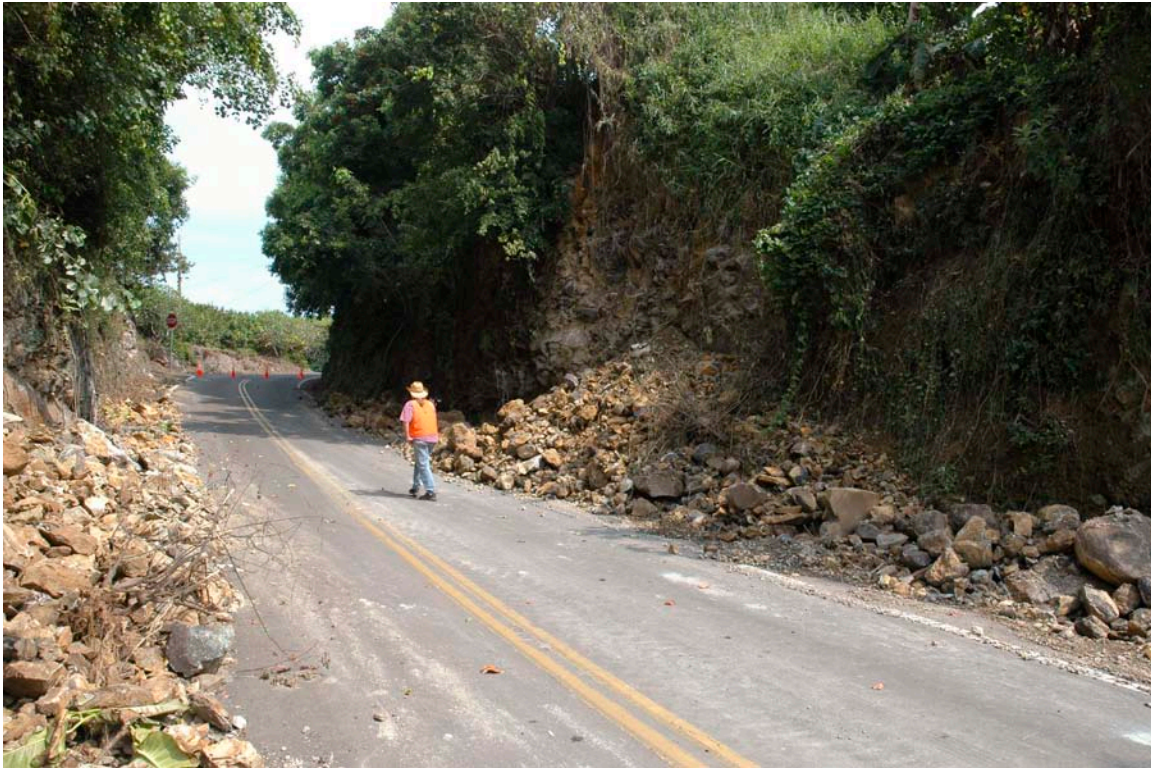
20.2. View from the opposite direction (from photo 20.1 (tjt1513)) of the road-cut failure, resulting in the rocky debris on Akoni Pule Highway (view to the east-northeast). CSAV photo by D.A. Whilldin, 10/19/2006 (daw005).

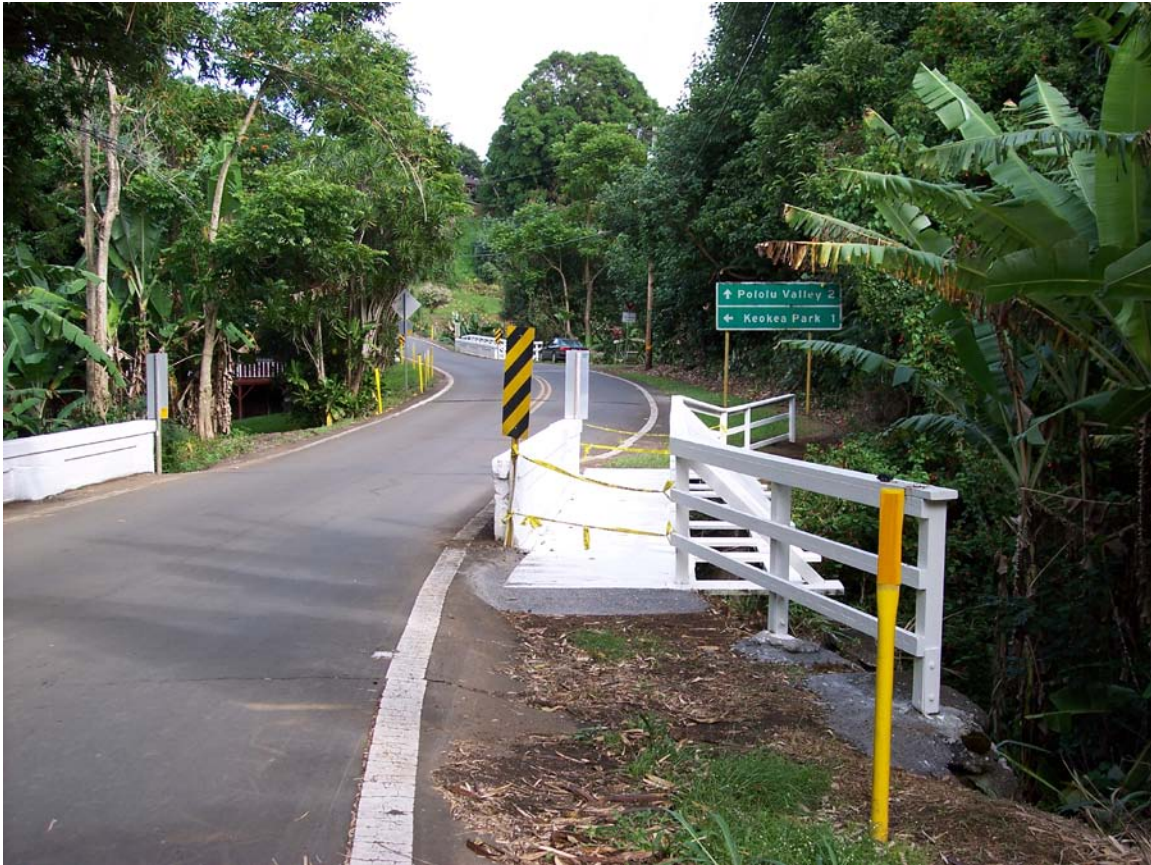
20.3. View of the Waikani Gulch one-lane bridge (foreground) and the Niuli‘i Stream bridge (background) near the intersection of Kēōkea Park Road. The bridge, repainted and repaired with fresh concrete reinforcing the fence posts and the base of the bridge, was yellow-tagged for restricted use after new cracks developed following initial repairs (view to the east). USGS photo by T.J. Takahashi, 10/21/2006 (tjt1521).

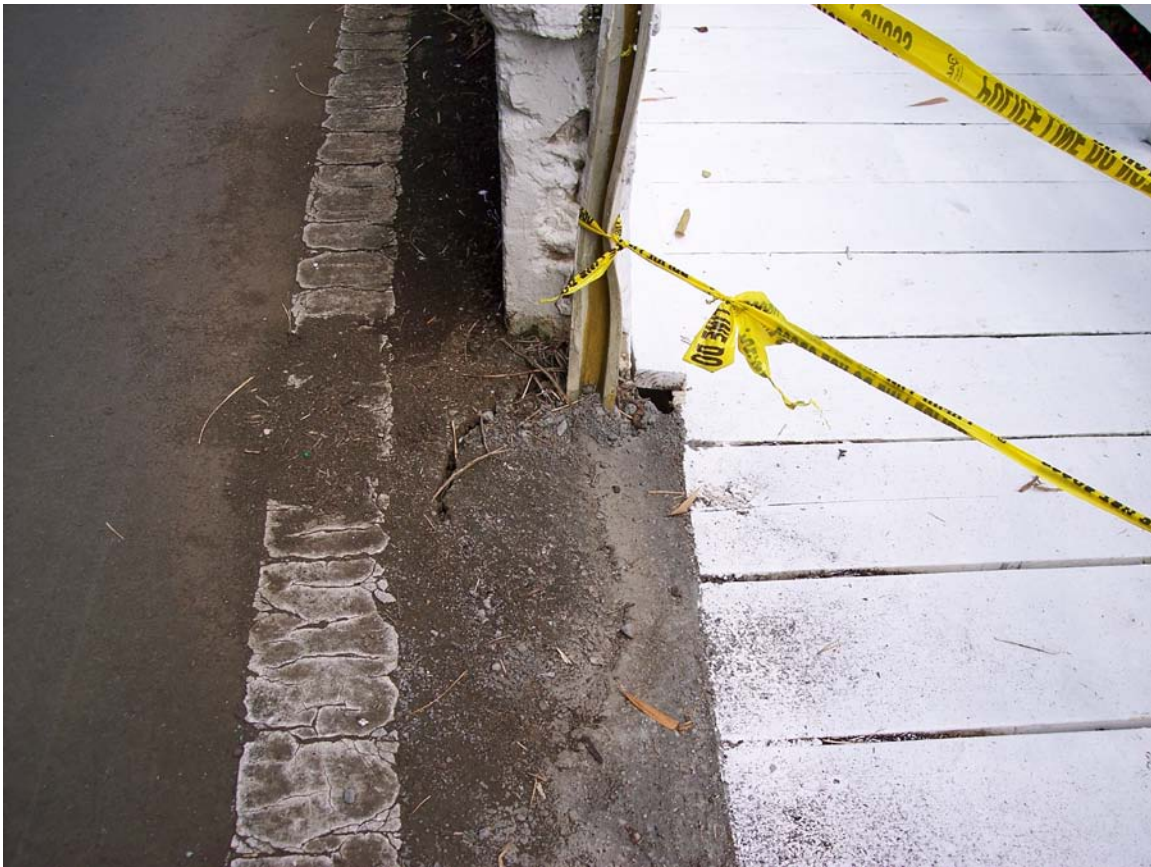
20.4. Close-up view of the cracks between the new concrete repair work and the road at the Waikani Gulch bridge (looking at the southwest corner of the bridge). USGS photo by T.J. Takahashi, 10/21/2006 (tjt1523).

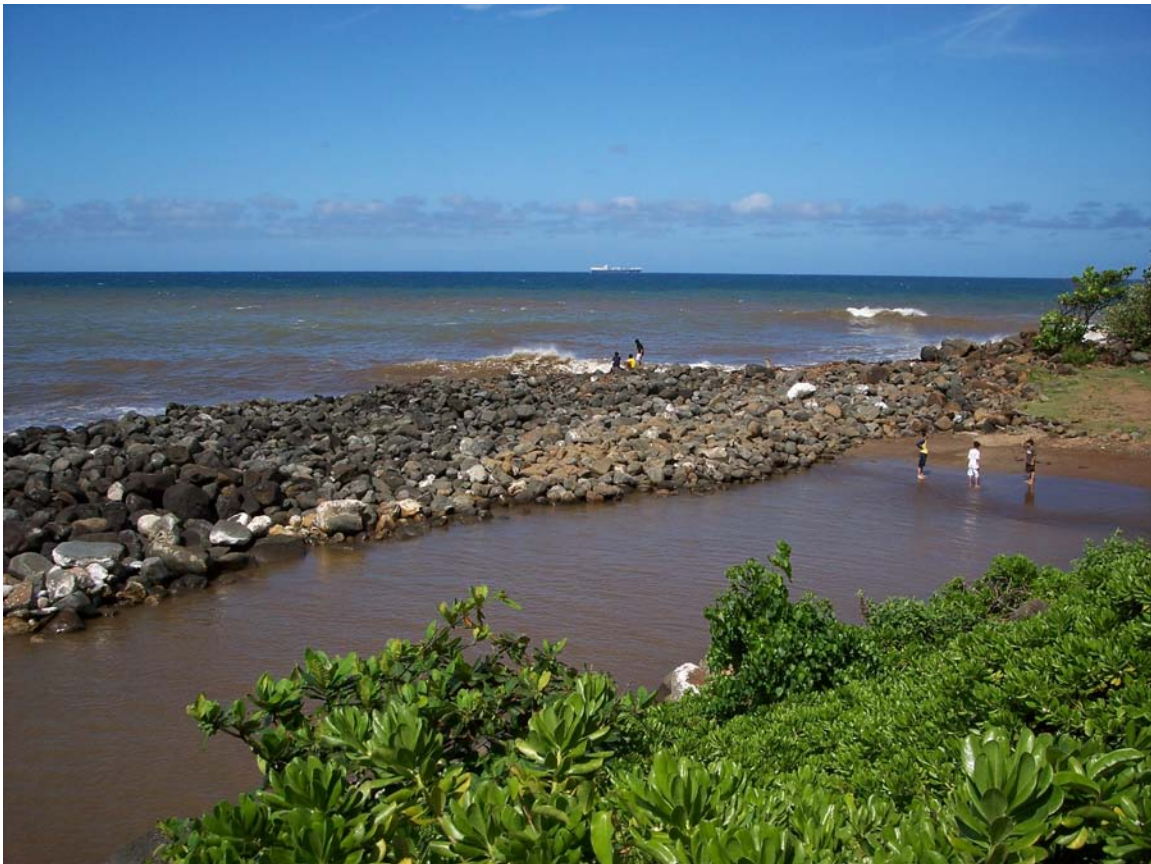
21.1. View of boulders and coastal waters along the northwest end of Kēōkea Beach after the rock slides and the rain-washed sediment into the ocean (view to the north). USGS photo by T.J. Takahashi, 10/21/2006 (tjt1437).

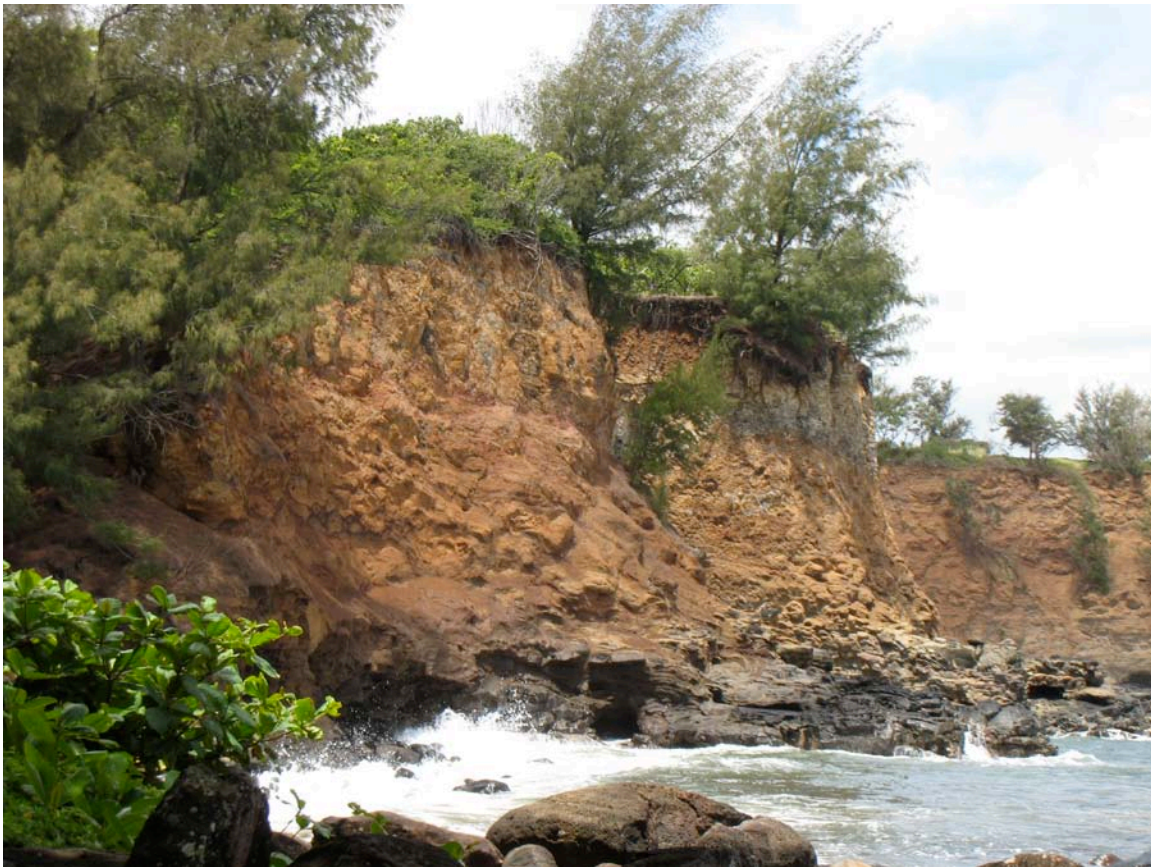
21.2. View of cliffs, barren from rock slides at Kēōkea Beach, nearly three years after the earthquake uprooted the ironwood trees that grew there (view to the southwest). USGS photo by T.J. Takahashi, 7/19/2009 (tjt1400).

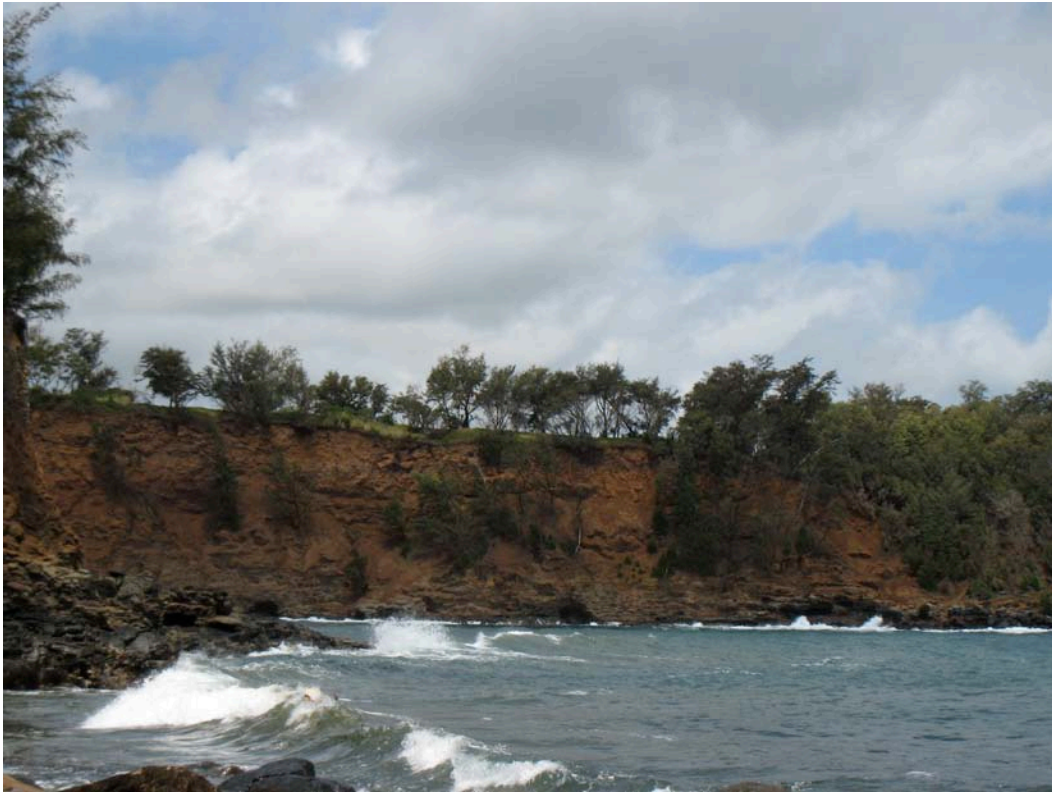
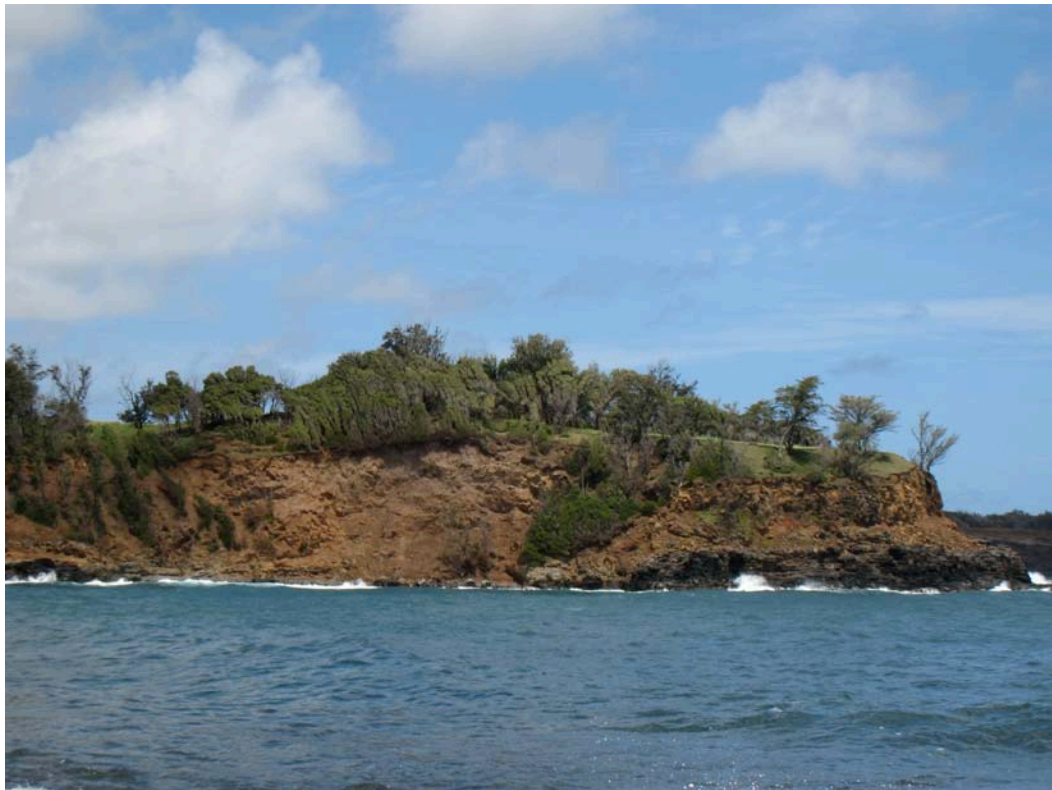
21.3 and 21.4. View of vegetation that recovered more quickly along the side of the bay less battered by wind and surf (view to the west-southwest). USGS photos by T.J. Takahashi, 7/19/2009 (tjt1401 and tjt1403).

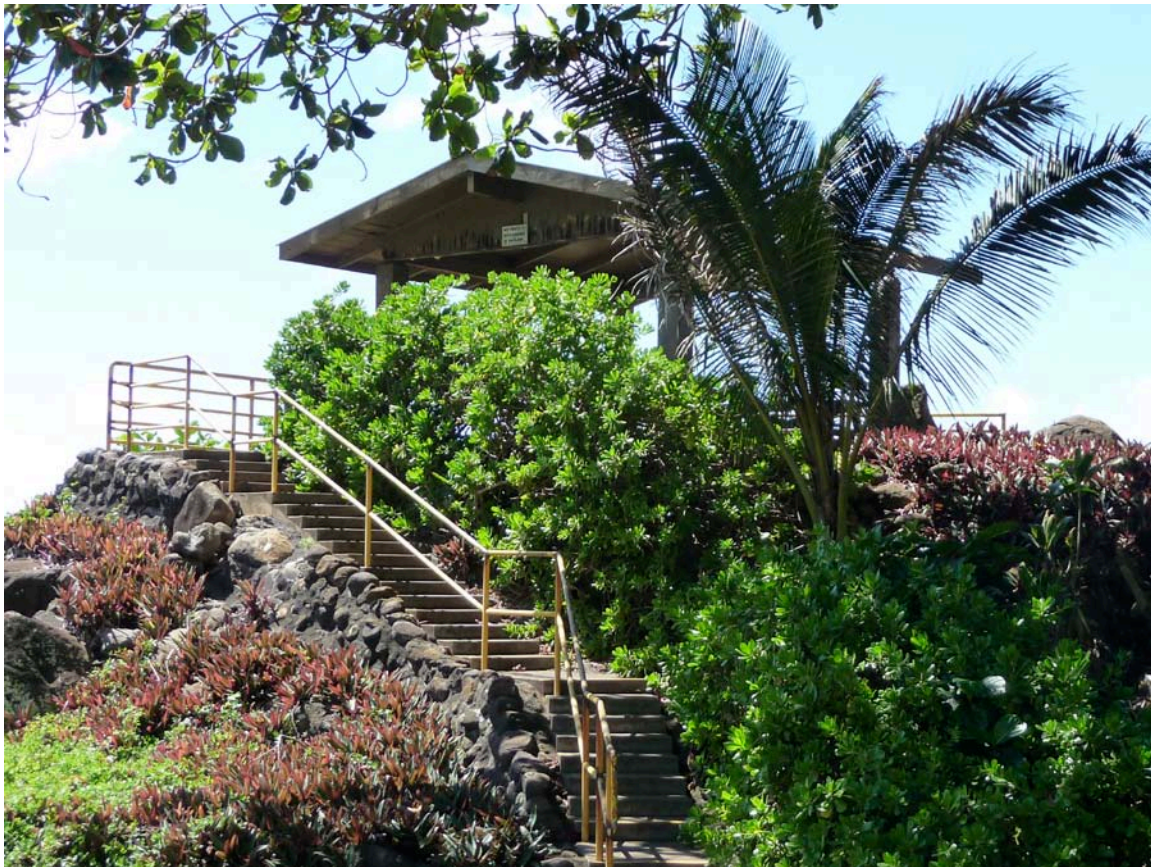
21.5. *Overview image:* The concrete staircase, supported by the stone wall, leads up to the gazebo, whose roof is visible above the shrubbery (view to the north-northwest). USGS photo by N.A. Ikeda, 6/25/2008 (nai312).

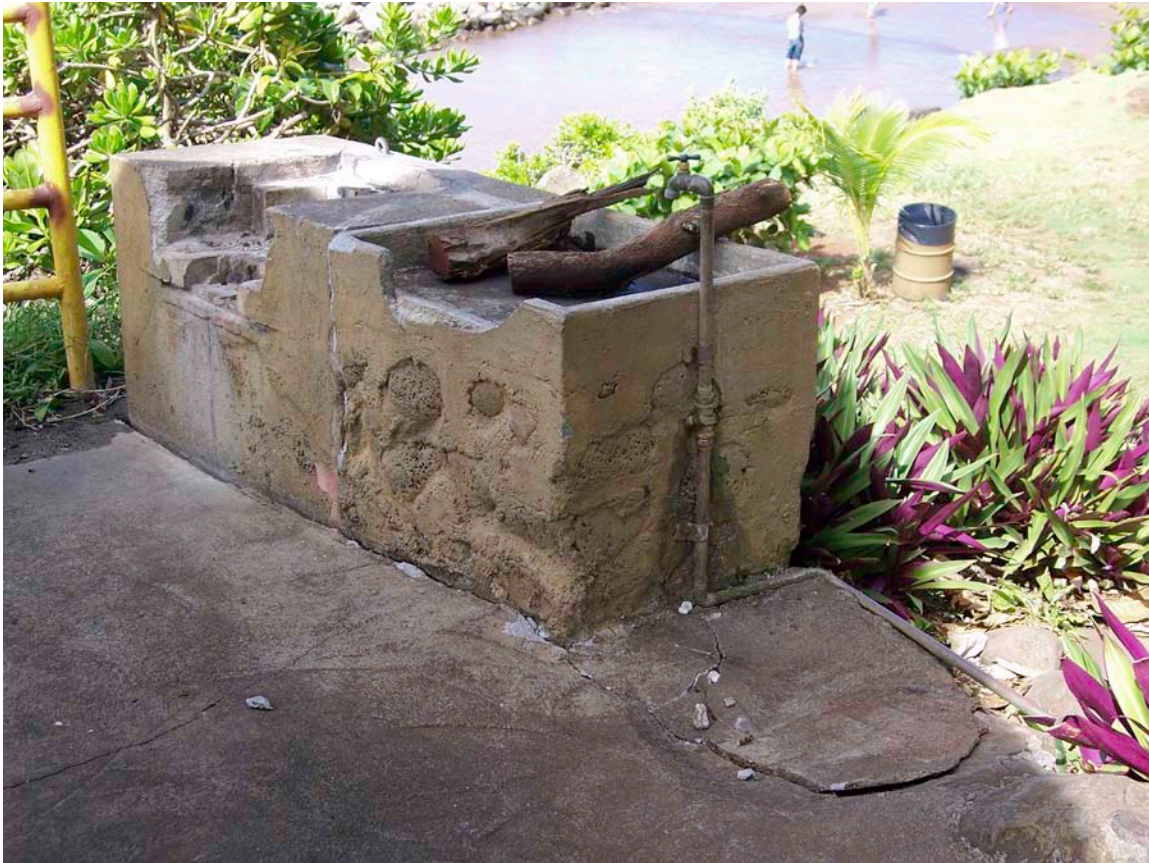
21.6. View of cracks in the concrete barbecue pit and pavement in the gazebo at Kēōkea Beach Park (view to the north). USGS photo by T.J. Takahashi, 10/21/2006 (tjt1444).

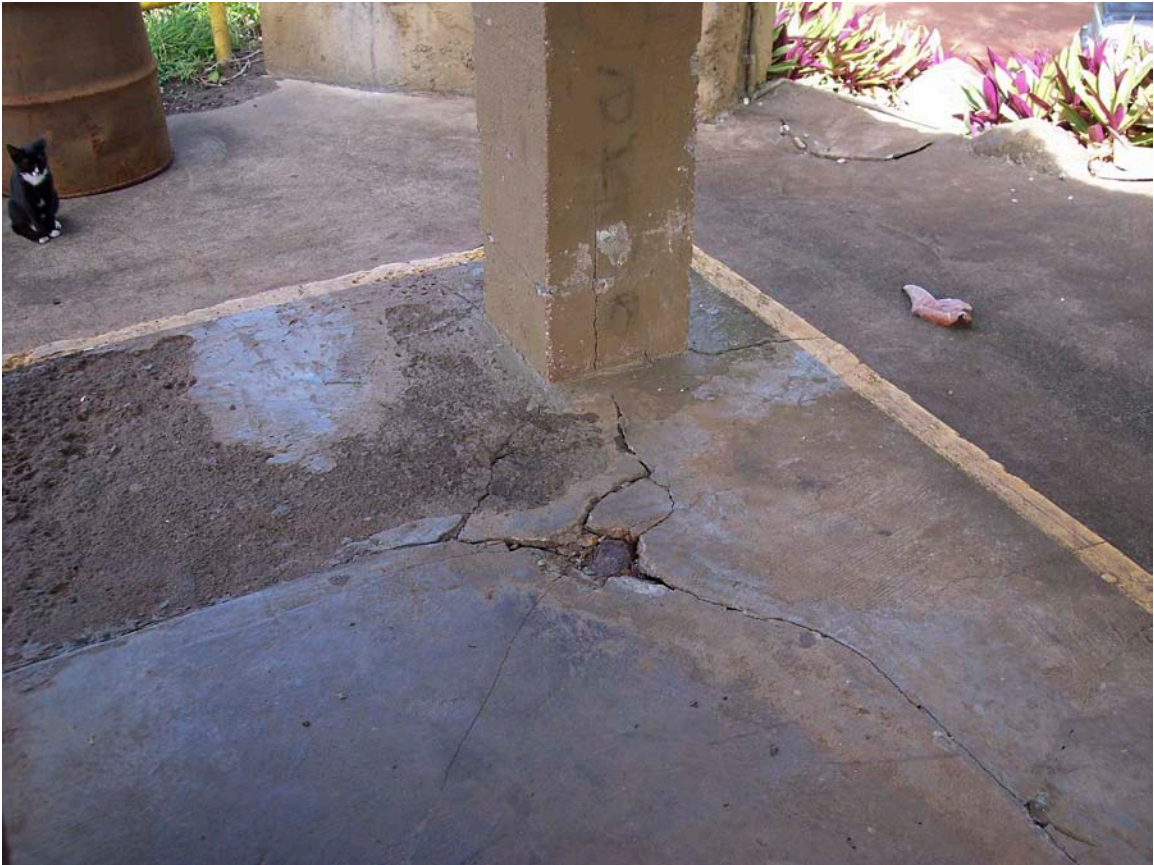
21.7. View of cracks in the concrete pavement and post of the gazebo (view to the north-northwest). USGS photo by T.J. Takahashi, 10/21/2006 (tjt1439).

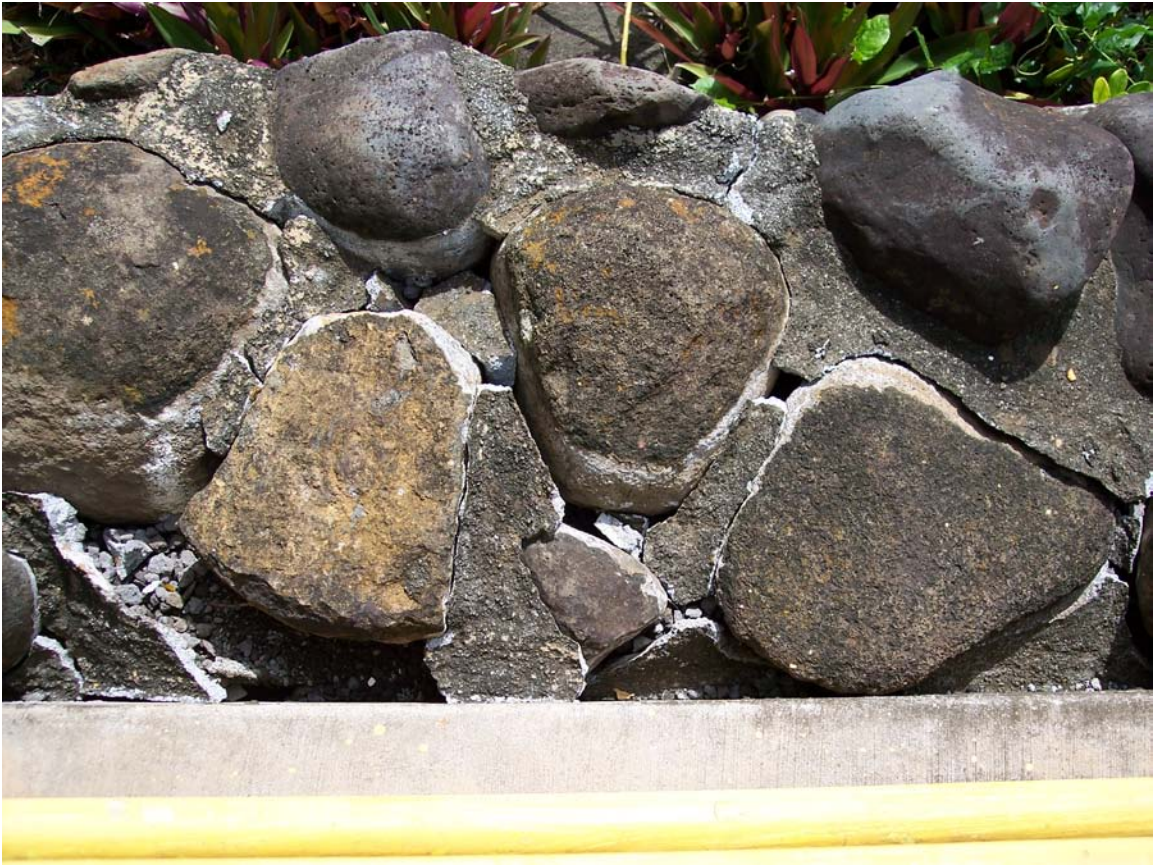
21.9. View of cracks in the mortar around the rocks in the wall next to the gazebo (view to the southwest). USGS photo by T.J. Takahashi, 10/21/2006 (tjt1450).

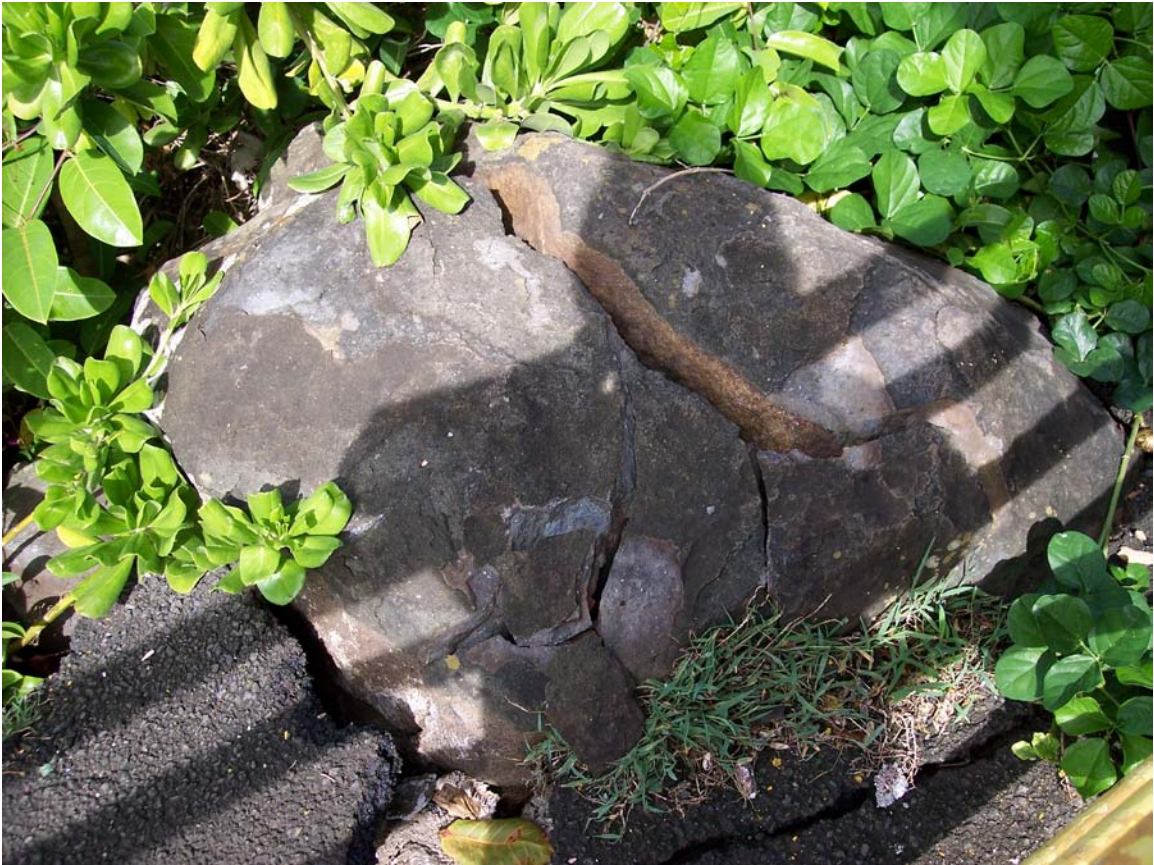
21.10. View of a fractured boulder, shaken loose from the asphalt, next to the gazebo (view to the north). USGS photo by T.J. Takahashi, 10/21/2006 (tjt1445).
